## SERVICE BULLETIN

**BULLETIN NO:** 09-005A

**TITLE:** Grinding Head Control

**PRODUCT SERIES / MODEL:** All RGH10 Series C Rail Grinders

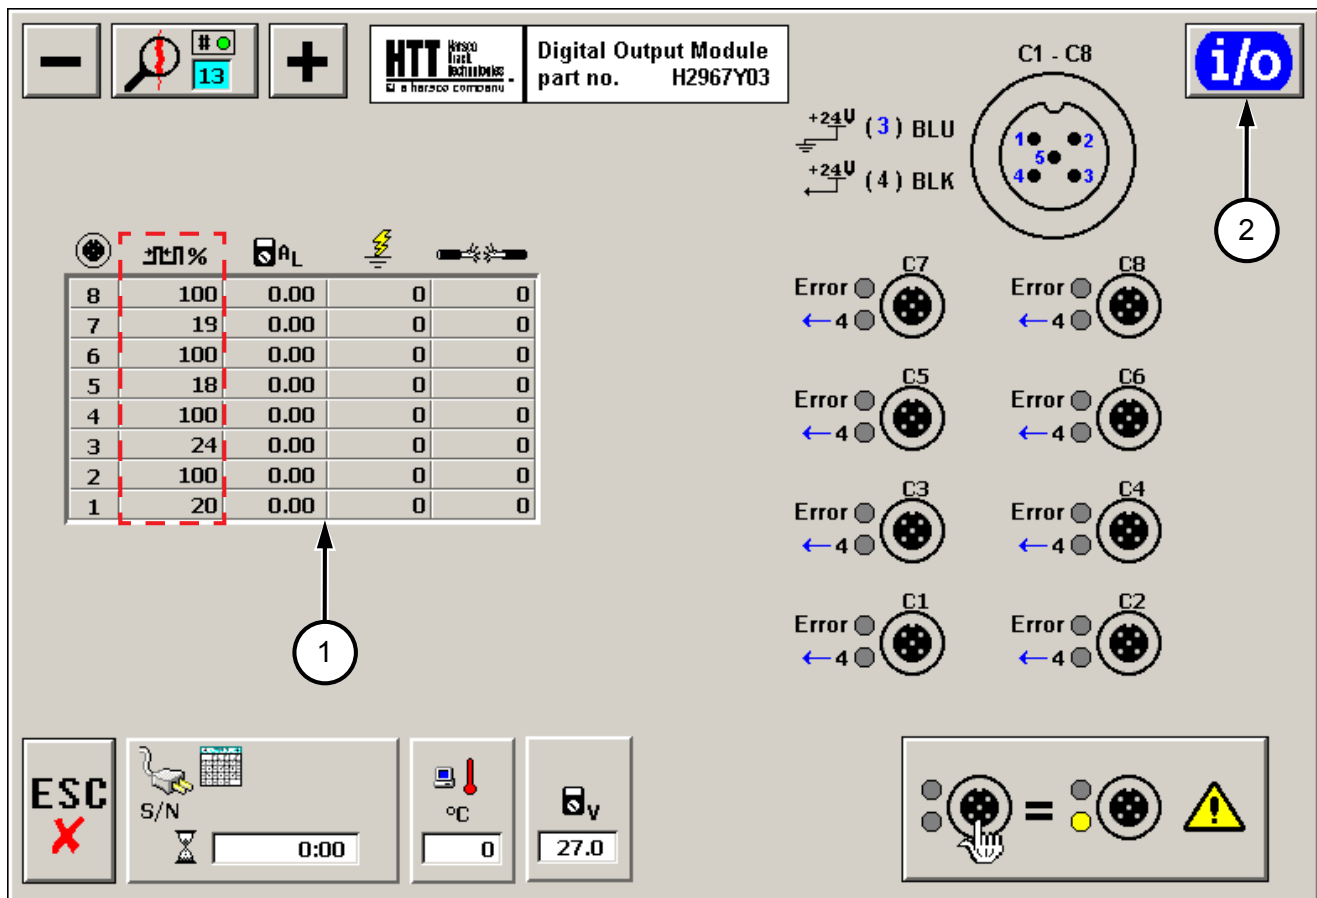
FIGURE 1  
DIGITAL OUTPUT MODULE - FEED CYLINDER SOLENOIDS

1. To verify that the feed cylinders are being controlled normally during machine operation, view the applicable Digital Output Module Diagnostic Screens that display the channel information for the Feed Cylinder Solenoids, outlined by a red dashed box, on the Information Table (1). Use the I/O Button (2) to confirm the function connected to each of the channels.

3. While grinding, watch the PWM values, outlined by a red dashed box, on the Information Table (1) to determine if the values are adjusting. Do not confuse the "Enable" solenoids with the "Control" solenoids, as the Enable solenoids will always display a 100% value while grinding.

4. Note that it is possible that the grinding head may ramp down its PWM control to its MIN PWM value and stay there if the target power for the pattern is lower than can be achieved. Be sure to monitor all 10 "Control" solenoids per car.

6. Verify the feed cylinders are being controlled normally following the instructions in this Service Bulletin. See Verifying Machine Operation.
7. If you should encounter this control issue behavior during the verification process or during actual machine operation, contact the Engineering Controls Department at the Harsco Rail, Columbia, SC. facility to verify what software is installed and potentially acquire the relevant update.
