SERVICE BULLETIN

MAINTENANCE OF WAY EQUIPMENT

BULLETIN NO: 14-010

TITLE: Field Service Bulletin for TURCK M12 Coupling Nuts and Valve Plugs

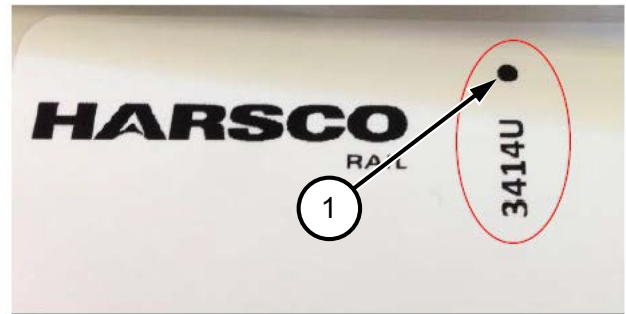
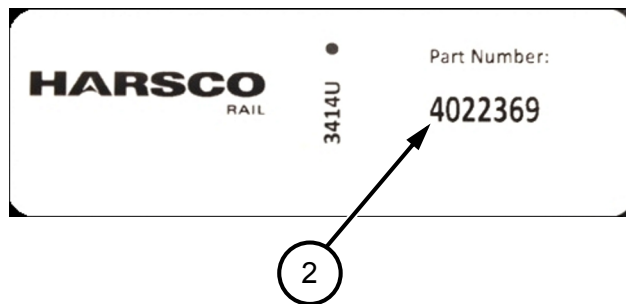
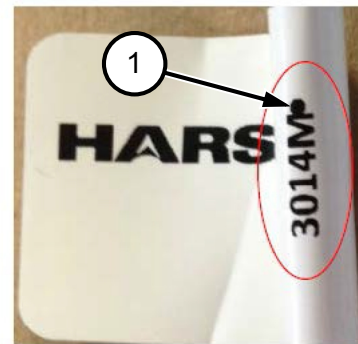
FIGURE 1
LABEL DETAIL

As a means to track the design change, TURCK implemented a special marking, a small dot adjacent to the TURCK Date Code, on the labels. All products bearing this special marking are the newly designed products. An example of the special marking, dot applied next to the date code, is shown in this Service Bulletin.

- (1) Dot Marking Next to TURCK Date Code
- (2) Harsco Rail Part Number
- (3) Ø15.0 mm Anti-Vibration Coupling Nut
- (4) Ø13.5 mm Coupling Nut - Identify and Return to TURCK for Replacement
- (5) Old Style Valve Plug with Visible LED
- (6) New Style Over Molded Valve Plug

1. Inspect your stock of Harsco Rail supplied cable assemblies with M12 connectors (sourced from TURCK). Determine if the cables have the 13.5 mm diameter coupling nut. Determine if the cable assembly with the M12 Male connector and the Valve Plug connector, new style, does not have a small dot marking near the TURCK Date Code. *Note: The cable end molding may be black, yellow or orange.*
2. If either cable issue is found, return the cables directly to the TURCK for replacement.

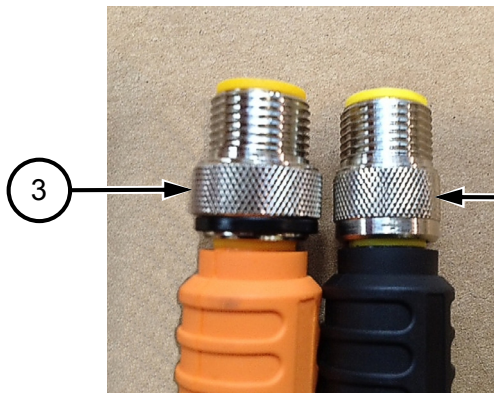
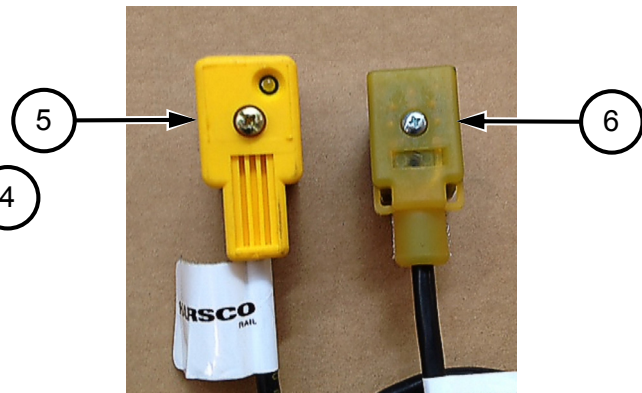
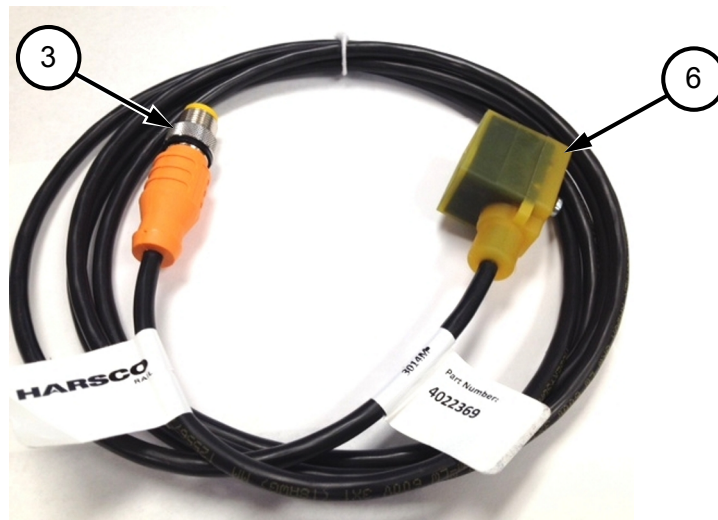
FIGURE 2
CABLE DETAIL

OPERATIONAL IMPACT: There is a low impact to Harsco Rail, their Customers, and Distributors. The cables with coupling nuts that have a 13.5 mm outer diameter across the knurling have caused some installation difficulties at Harsco Rail manufacturing facilities and for our customers. There is not a torque tool available for use with the smaller diameter 13.5 mm coupling nut.

There exists a risk of LED component failure or weak light caused by the original Valve Plug design change. Internal PCB cracking during the epoxy filler curing process, which causes an operational fault failure between the PCB resistor and LED.

1. Fill out all required information on the attached TURCK supplied form, RMA - Warranty No. 43820.
2. Insure that all customer identification data is included on the form to help expedite the direct shipment of replacement cables.
3. Utilize the provided TURCK direct shipment UPS Number: 562804 or 67X281 to return the cables pre-paid to TURCK Industrial Automation.
