## SERVICE BULLETIN

**BULLETIN NO:** 20-008A

**TITLE:** CALLISTO MOUNTING WING UPDATE

**PRODUCT SERIES / MODEL:** All versions of:  
PT-0902-001 (MKIV HD with Callisto since 03/2019)  
PT-0902-002 (MKIV with Callisto since 03/2019)  
PT-0902-003 (MK III with Callisto since 03/2019)  
PT-0902-004 (6700 with Callisto since 03/2019)

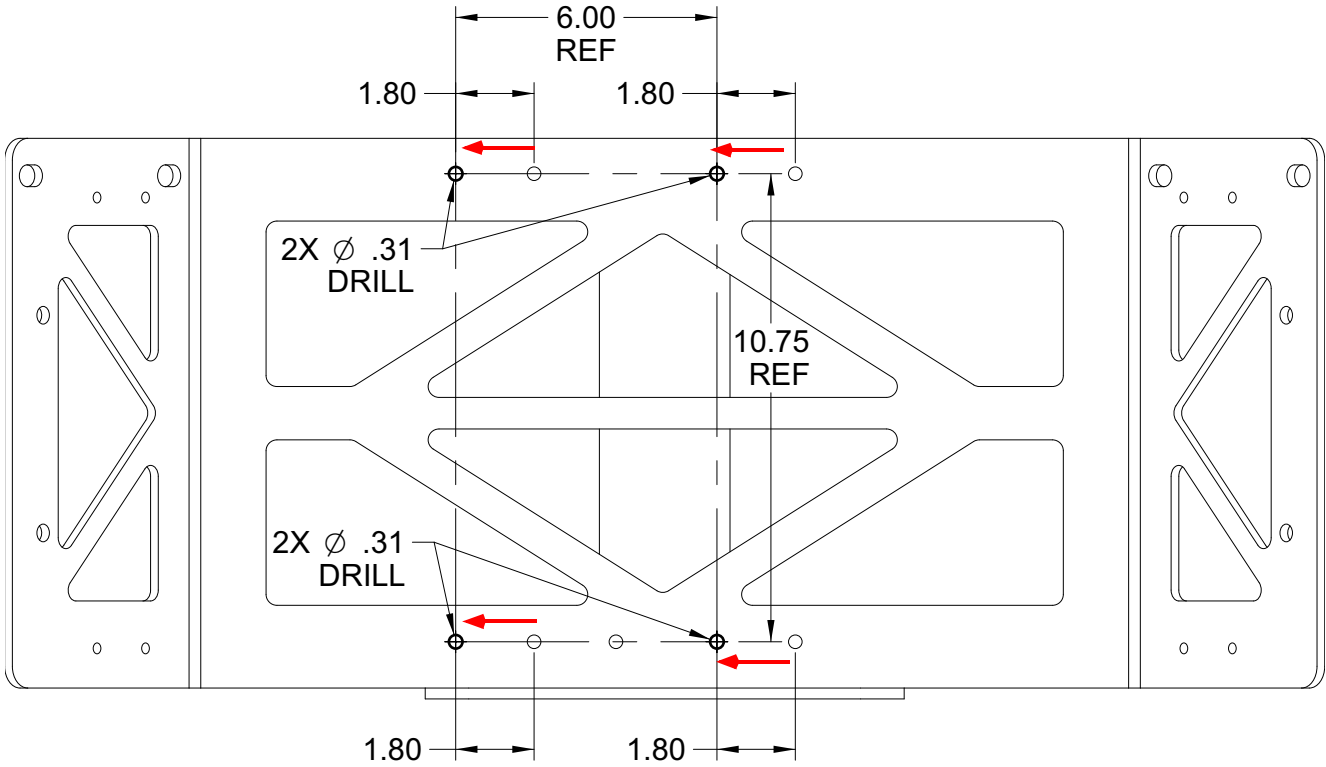
FIGURE-1  
CALLISTO WING MODIFICATION - MOVE BOX LEFT

If the Arrow on the IMU Decal IS NOT aligned with the Machine Centerline, the Callisto 2 Box Assembly must be offset 1.80 inches in the proper direction, left or right - in order to align the IMU Decal Arrow with the machine centerline. This will require new mounting holes to be drilled in the Callisto Wing bracket to properly mount the Callisto 2 Box Assembly.

1. Remove Callisto wing and box.
2. Remove box from wing, noting the orientation of the box on the wing.
3. Following the drill pattern shown in Figure 1 or Figure 2, make four new 5/16" (.31 inch) diameter holes. Offset the new holes 1.80 inches from the existing holes.
4. Mount box back onto wing using the newly drilled holes - in the same orientation it was in prior to removal.

*Note: Ensure that the box is not rotated 180° from its original mounting - this orientation must be maintained when remounting the box to the wing.*

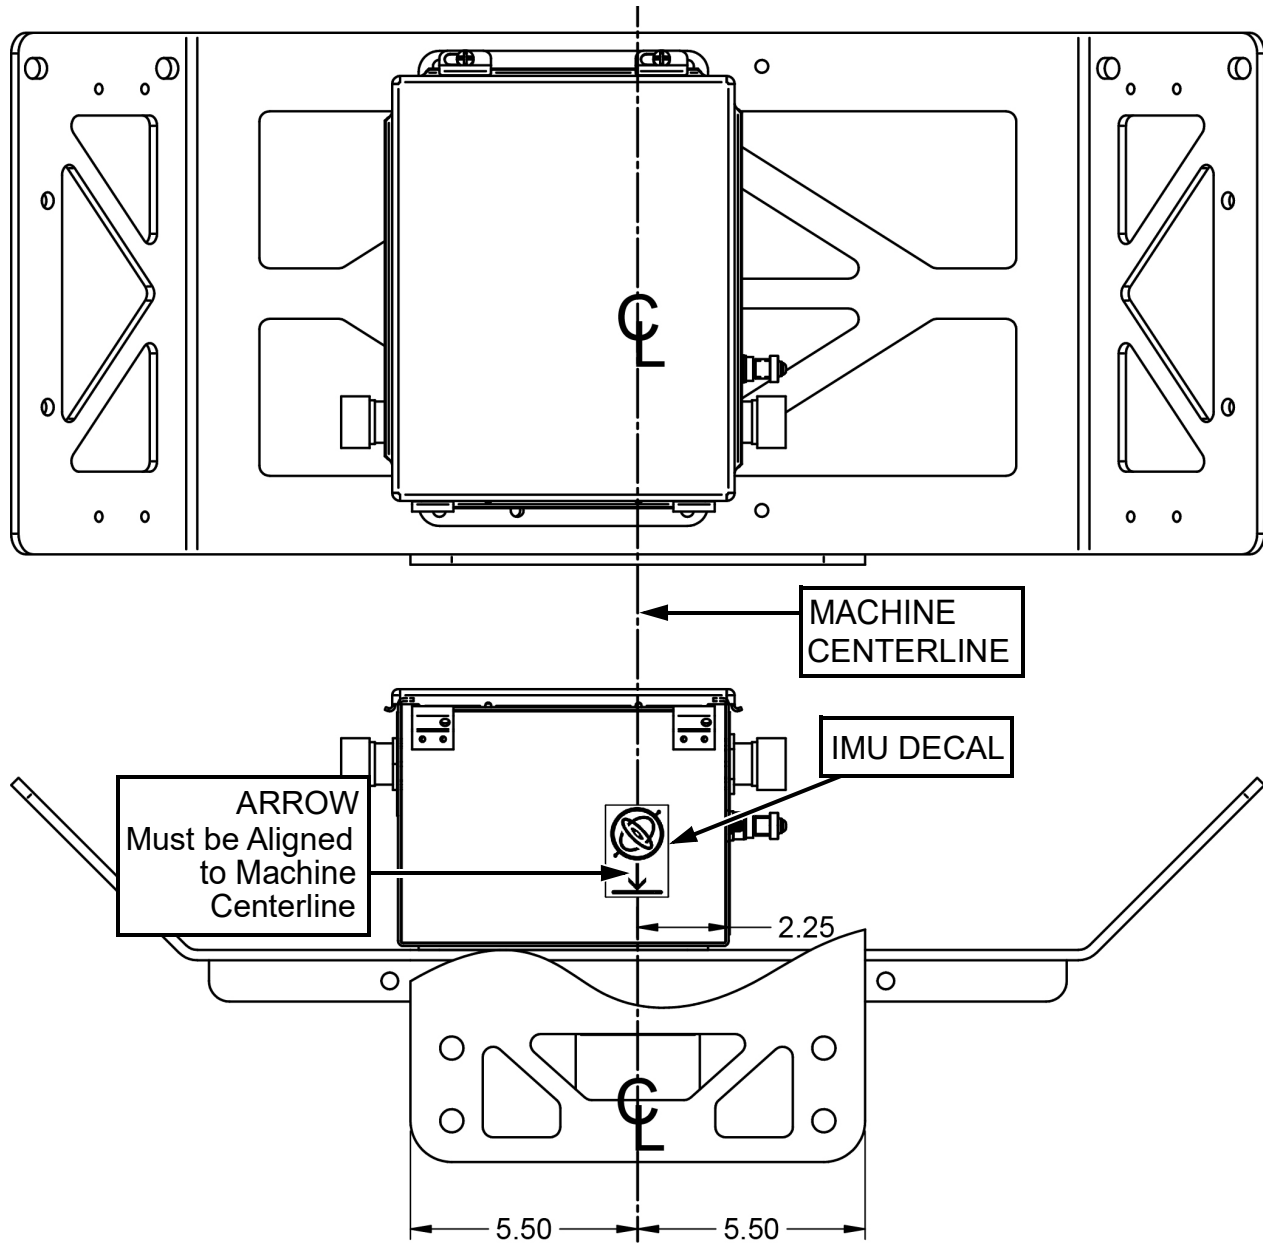
**FIGURE-3**  
**CORRECT PLACEMENT OF THE BOX SHOWING THE IMU DECAL**

On the side of the Callisto 2 Box Assembly there is an IMU Decal. The IMU decal must face either the front or the rear of the machine. The decal has an alignment Arrow on it. If the Arrow on the IMU Decal IS aligned with the Machine Centerline, the Callisto 2 Box is mounted properly, and the Callisto Wing does not require updating.

5. Mount box and wing back onto tamper.
6. Verify that the IMU Decal Arrow is accurately aligned with the centerline of the machine.  
- (See Figure 3)
7. Verify box operation by recording track.
8. Sync back into the recording and check superelevation using a level board.

1. When remounting box, ensure that the Arrow on the IMU decal is accurately centered along the centerline of the machine.
