SERVICE BULLETIN MAINTENANCE OF WAY EQUIPMENT

DATE: 2-11-2003 **BULLETIN NO:** 03-003

TITLE: LINING MASK LINEAR ACTUATOR SERVICE INFORMATION

PRODUCT SERIES / MODEL: 6700 Tampers

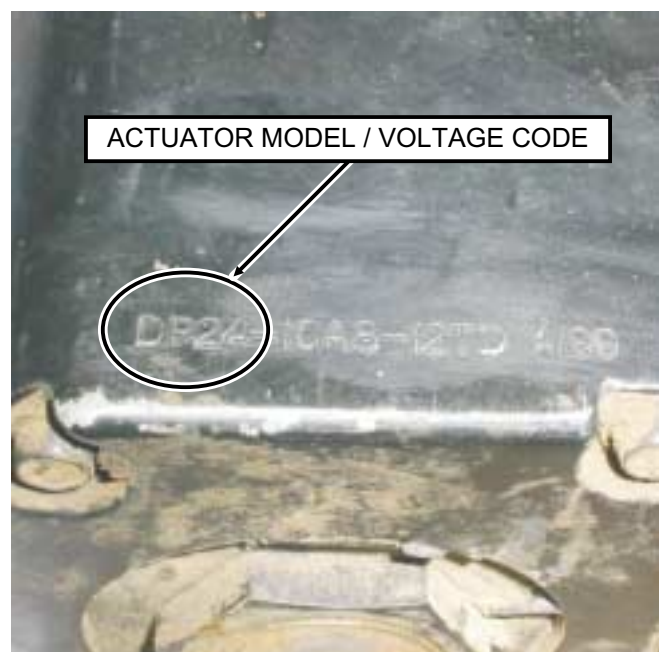
FIGURE 1

PROBLEM CORRECTIONS**1. EXCESSIVE HUNTING** - See Figure 1

Verify that the actuator voltage rating is compatible with the design specification. HTT units are intended for operation on a 24 volts DC control circuit. Units rated for less than 24 volts will spin faster than intended, take longer to stop spinning when power is removed, and result in the mask "overshooting" the correct position. It then has to reverse direction to obtain the desired position, only to overshoot again. This overshoot and reverse cycling, called "hunting", causes premature gear and ball assembly wear, electric motor temperature rise, premature motor brush / armature wear, and potential motor burnout.

To check the actuator motor voltage rating, find the manufacturer's model code, located on the end cover (housing the feedback gears and potentiometer). On one side should be listed a 16 digit code, in groups of four, separated by spaces or dashes. The leading or 1st four digits designate the model and voltage rating, and should read "DP24" as shown in Figure 1.

Units that do not match the "DP24" model / voltage rating should be removed from service immediately.

Please note that the end covers are interchangeable, and all efforts should be made to keep the original cover with the original housing, to prevent inadvertent confusion about motor voltage ratings.

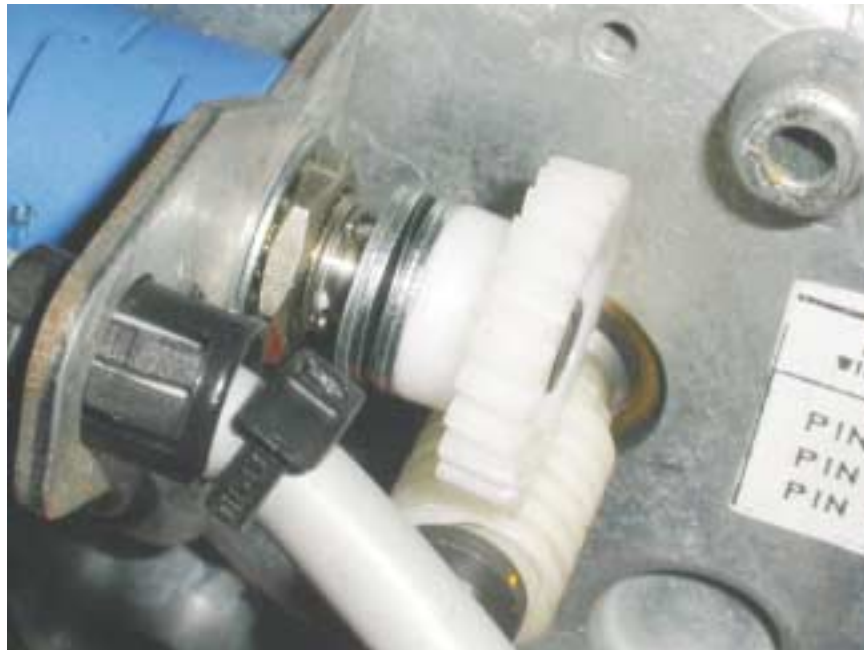
FIGURE 2

The actuator calibration is dependent on proper feedback from the actuator position feedback potentiometer. This "pot" incorporates a drive pinion gear that meshes with a worm gear attached to the end of the ball screw. The drive pinion gear seated on the "pot" is a slip-clutch design to prevent potentiometer damage in the event that the gear is rotated beyond the limits of the pot stroke.

There have been instances where the clutch mechanism has exhibited slip (and subsequent loss of calibration) when in side-loaded conditions. This can be caused when the mounting bracket has been adjusted to remove all backlash, and then tightening the mounting screws forces the gear even closer, so that there is excessive side load on the gear. The side load can bind the pot shaft enough to exceed the clutch slip force, so the pot gear turns, but not the shaft. This throws off the actuator calibration.

HTT recommends that the pot mounting bracket be adjusted so that the pot gear has a very minimal amount of backlash, with no axial force generated on the pot shaft. You should be able to rotate the pot gear a very slight amount when rocking it by hand while it is meshed with the worm gear. This will prevent side loading of the shaft, which can cause the pinion gear to turn on the pot shaft during normal operation, and affect the calibration of the lining mask actuator. To adjust, loosen the two mounting screws holding the pot bracket, and position the pot gear on the worm gear so there is slight backlash (making sure the pot gear is also centered over the worm gear). Then, carefully tighten the screws, and re-check for the slight amount of backlash when completed.

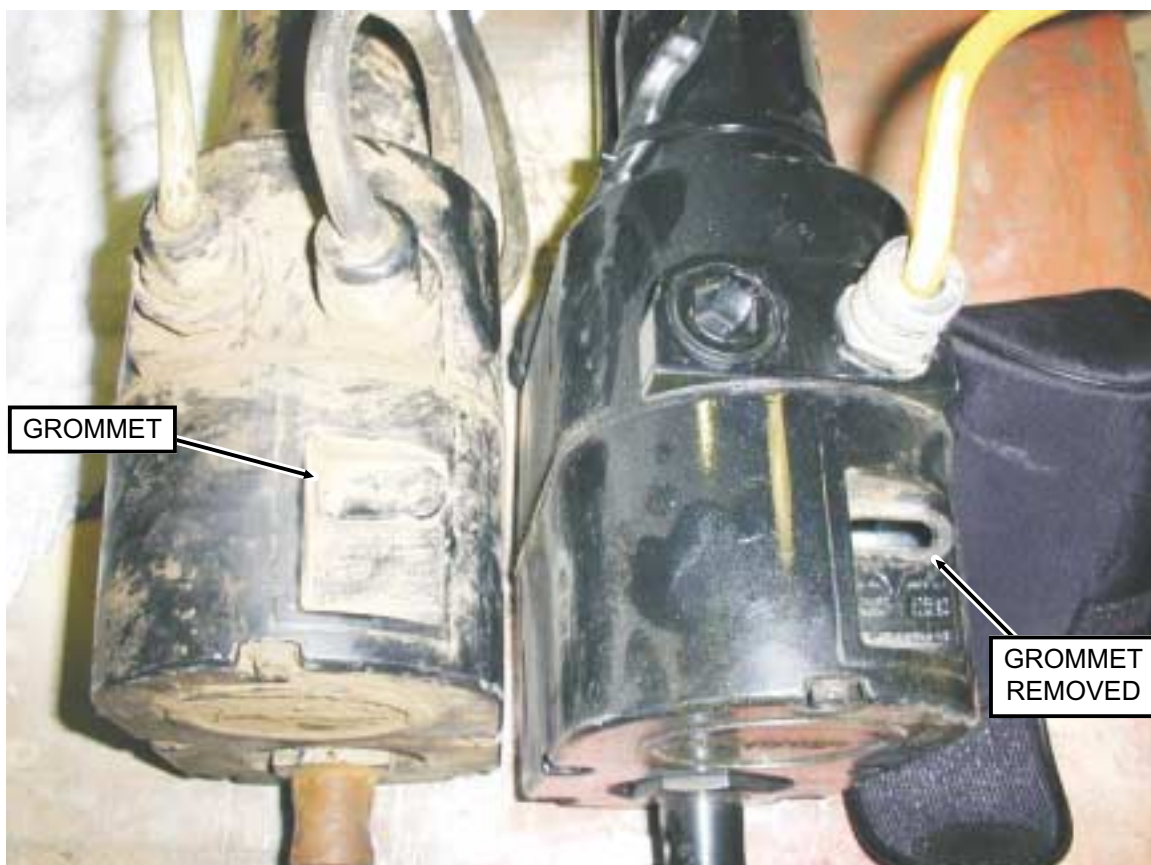
FIGURE 5

3. INTERNAL CONTAMINATION - See Figure 5

Some Linear Actuators returned to HTT for service have exhibited signs of contamination due to moisture ingress, resulting in rust buildup and grease contamination. One common thing noticed on the units returned that show the moisture contamination is that the factory-installed grommet, located on the base of the center section of the motor end, had not been removed, allowing condensation and gasket failures to permit moisture buildup internally. HTT supplies the linear actuator with this grommet removed, so as to allow the drainage and evaporation of any moisture entering the housing. Lining Actuators in the field that have this grommet installed should have them removed.

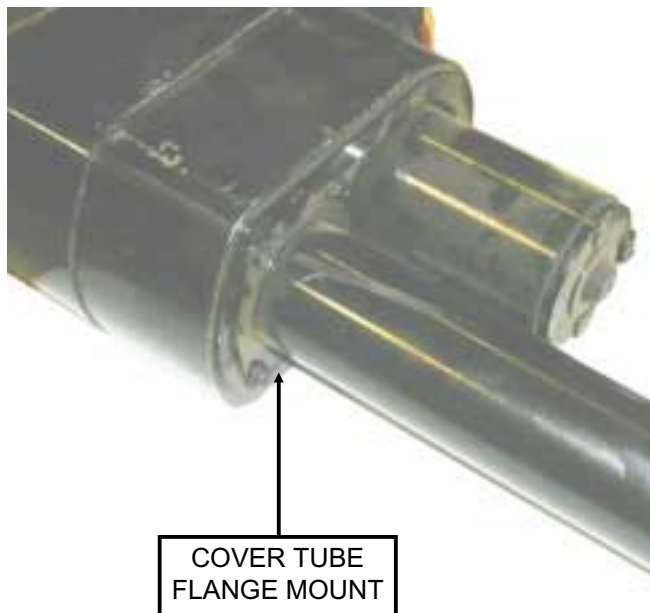
FIGURE 6

4. ACTUATOR COVER TUBE FAILURES - See Figure 6 and Figure 7

In June of 2001, HTT Engineering implemented a change in the purchase specification for the Lining Mask Actuators. This was done to correct problems reported where the cover tubes were bending, cracking, and/or breaking at the mounting flange. (Bending has been attributed to extreme side force, such as mask follower derailment). The new specification calls for a thicker wall material to be used, making the flange area structurally more robust. The new thicker-wall cover tube (HTT Part # 2004471) is not directly compatible with older units (rod seal diameter is different than older units), and both the screw assembly and the cover tube must be replaced at the same time when rebuilding. See the Service Parts List included in this Service Bulletin for the "Kit Option" part number to use when rebuilding older lining mask actuators.

Cover Tubes may be inspected and replaced by removing the 4 flange mounting plate bolts, and then sliding the tube off the extension rod assembly. Inspect the flanges for cracks at the bend on the inside corner of the flange, and also for signs of bending or distortion of the flange itself. Replace any cover tube showing any signs of damage. When re-installing the cover tube, make sure the gasket is in place and properly seated under the flange mounting plate.

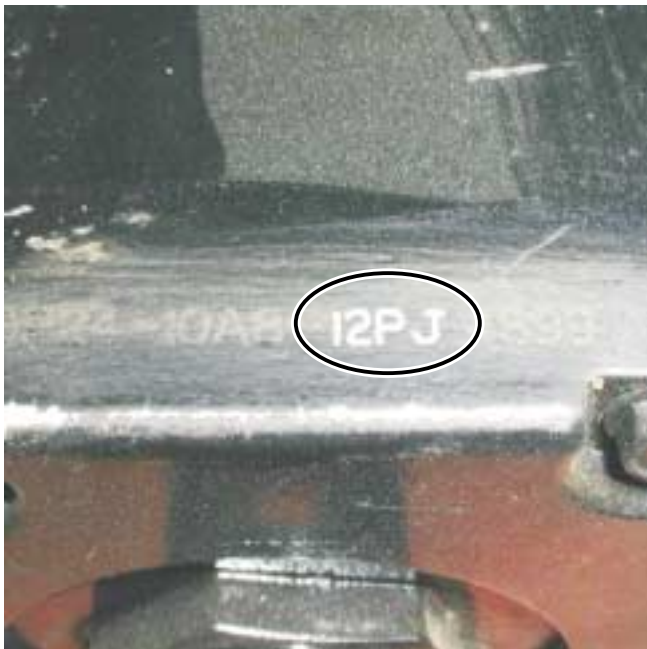
FIGURE 8

Note: All actuators of HTT origin distributed with the thick-wall cover tube after June 2001 can be identified by the presence of the letters "12PJ" in the 3rd group code stamped on the actuator cover as shown in Figure 8.

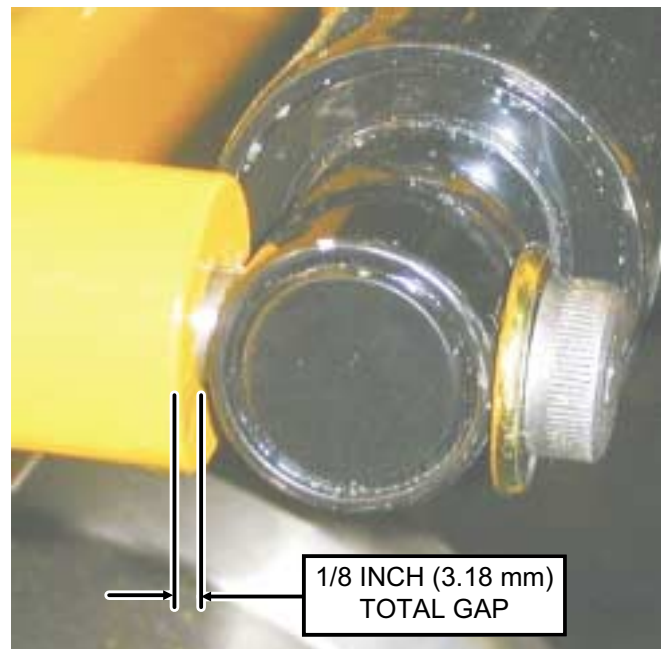
FIGURE 9

Also noted during investigation of tube failures was the potential for binding the extension rod when mounting the units to the mask assembly. The original design called for a flat washer to be used on both sides of the extension rod when installing the shoulder bolt that holds the rod to the mask assembly. This can, in some instances, captivate the extension rod, causing binding that can help contribute to tube failures. Current design specifies only one washer to be used. This allows some free play (float) in the lateral direction, and keeps the end of the extension rod from being "clamped" in position during extend/retract cycles.

With the washer installed on the bolt head side, the actuator rod should be centered on the shoulder bolt diameter, and free to move about 1/16 inch (1.59 mm) in either direction, and not pressed to one side in either direction. If the actuator is pressing against the flat washer installed toward the head of the shoulder bolt, and cannot freely move toward the mounting post, remove the shoulder bolt, install the flat washer on the post side of the rod, then re-install the shoulder bolt using Loctite 242 (Blue). Check the alignment of the rod on the shoulder bolt diameter, making sure it has freedom to move the 1/16 inch (1.59 mm) in each direction, for a total movement amount of 1/8 inch (3.18 mm).

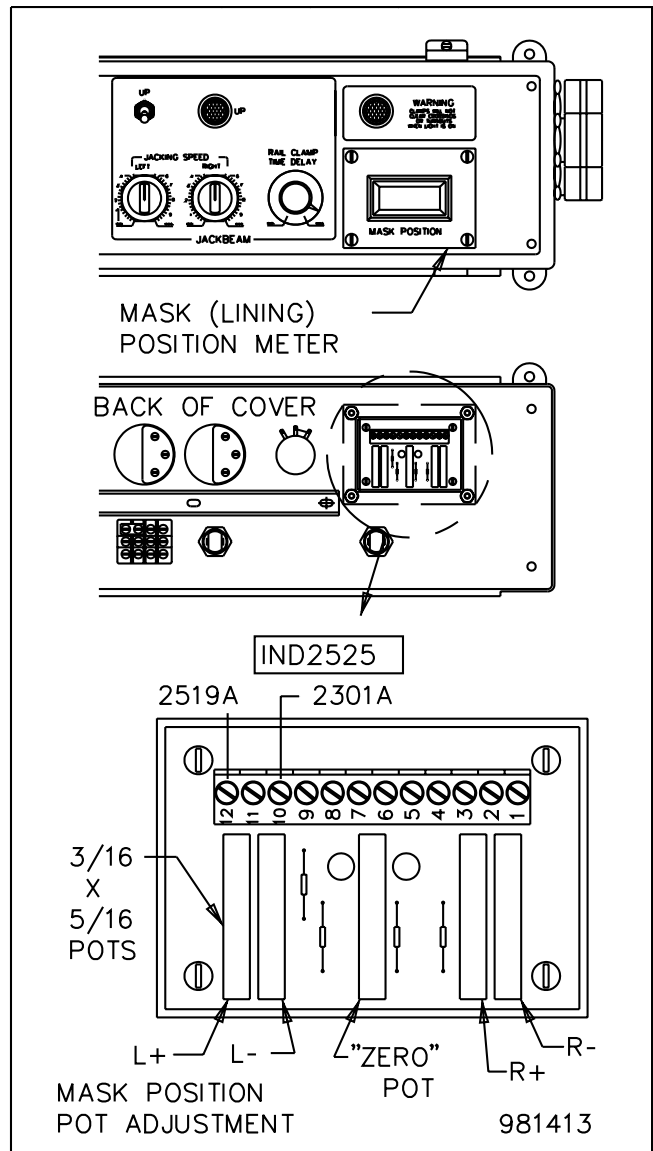
FIGURE 10

5. LINING MASK ACTUATOR CALIBRATION - See Figure 10

- 5.1 Disconnect rod end of actuator from mask assembly.
- 5.2 Run actuator to full extension, then allow rod to rotate for approximately 10 seconds to set pot gearing and pot stroke correctly. (This sets the pot at full travel position with full screw extension, and sets the total pot adjustment range to be within total actuator screw stroke).

- 5.3 Re-connect rod end to mask assembly, then retract rod fully. **Do not let the rod rotate during retraction by not mounting it up first!** (This would change the pot setting from the full-extension value just set, and make calibration very difficult, if not impossible, without repeating the entire procedure).

- 5.4 Using mask position switch, position mask at 8.00 inches from "Unity" mark established during Lining Unity Calibration (See Section 6.5.4 of the Operator's Manual). Accurately measure (to the nearest tenth of an inch) the position using a tape measure or scale.

- 5.5 Calibrate the Lining Mask Position Meter by measuring the actuator feedback with a voltmeter, reading between terminals 10 and 12 (wires #'s 2301A and 2519A), located on the back of the lining mask position meter. Adjust the "Zero" pot to read the same as the feedback voltage to the nearest tenth of a volt.
- 5.6 Retract mask 1.5 inches from the Unity mark, by accurately measuring (nearest tenth) the distance from the "Unity" mark with a tape measure or scale.

- 5.7 Adjust the "R-" or "L-" pot (depending on which lining actuator calibration you are doing - Right side or Left side) so that the meter reading corresponds to the 1.5 inch retracted travel position (A 1.5" retracted position should read "-15" on the meter - meaning "fifteen tenths of an inch (1.5 inches) less than Unity" (toward gauge).

- 5.8 Extend mask 9.5 in. from the Unity mark, by accurate measurement (to the nearest tenth).
- 5.9 Adjust the "R+" or "L+" pot (depending on which side is being calibrated) so that meter readout corresponds to the actual measured travel position (A 9.5" extended measurement should read "95" on the meter - meaning "ninety-five tenths of an inch (9.5 inches) greater than Unity" (toward field).

- 5.10 Because the adjustment of one pot affects the calibration of the other (you are changing the voltage setting at each end of the stroke of the actuator feedback pot), the process of extending and retracting the mask, and adjusting the pots so the meter reflects the actual position, must be repeated until both positions read correctly with no further pot adjustments (9.5" = 95 on Mask Pos. Meter, and -1.5" = -15 on Mask Pos. Meter).
