SERVICE BULLETIN MAINTENANCE OF WAY EQUIPMENT

DATE: 4-14-2003 **BULLETIN NO:** 03-005

TITLE: 200685 SLC 503 CPU OPERATING SYSTEM AND MEMORY UPGRADE KIT
200714 SLC 500 DTAM FIRMWARE UPGRADE KIT

PRODUCT SERIES / MODEL: W96 Series E and F Spike Drivers
RMC306 Series C Anchor Boxers

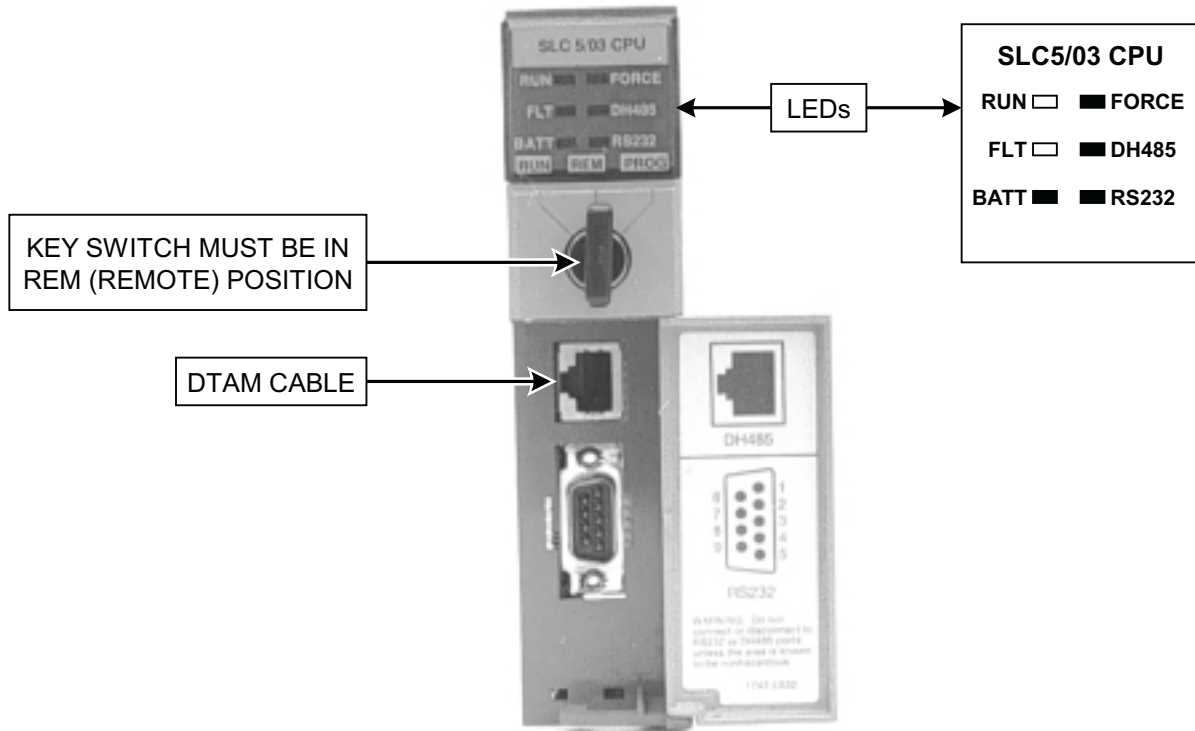
FIGURE 5
SLC 503 CPU MODULE - FRONT VIEW

37. After Operating System has been successfully upgraded in approximately 2-1/2 minutes, four LEDs (RS232 - DH485 - FORCE - BATT) on front of CPU Module will remain On steady as shown in Figure 5.

24. Remove all power from machine.
25. Locate existing CPU Module in CPU Box on machine.
26. Open access door on front of CPU Module.
27. Disconnect DTAM Cable from CPU Module by depressing lock tab and pulling cable straight out.
28. Depress top and bottom locks on CPU Module and pull module straight out of rack.
29. Look at Operating System data label on side of CPU Module. The Operating System is identified as OS300, OS301, OS302A, OS302B or OS302C.
 - 29.1 If Operating System is OS302C, this Operating System will support new M13 Memory Module # 200684 and/or existing M11 Memory Module F026079. Go to Step 42.
 - 29.2 All other Operating Systems other than OS302C require Upgrade Module # FOR007526 to support new M13 Memory Module # 200684. Go to Step 30 to install new Operating System OS302C.

30. Remove existing M11 Memory Module # F026079 from socket on CPU Module.
31. **Important:** Move jumper from "PROTECT" to "PROGRAM" on CPU Module.
32. Remove Upgrade Module # FOR007526 from shipping package. Install Upgrade Module in socket on CPU Module.

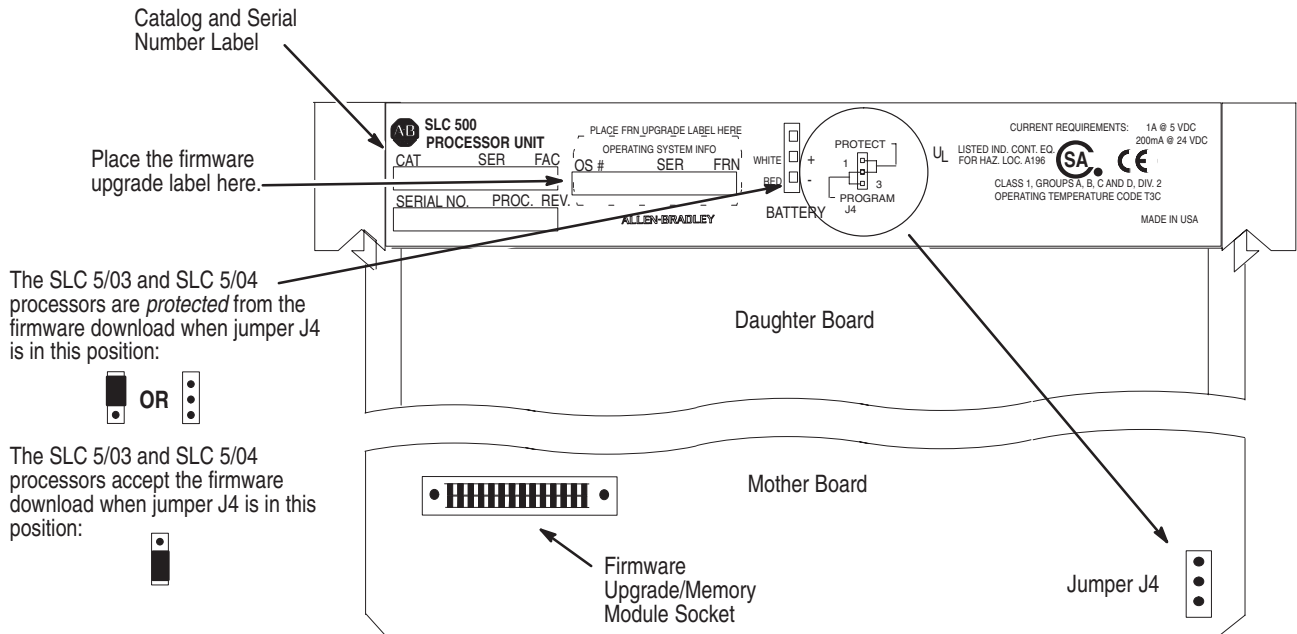
Figure 1 Component Placement Information

Failure to return the J4 jumper to the protected position results in an error (0x3D Hex) on the power cycle following the download of a valid program to the processor. This error condition prevents the module from going to run and causes Channel 0 communication settings to return to their defaults. To properly clear the error, place the J4 jumper in the protected position, and then re-download a valid user program to the processor.

4. Remove the processor from the chassis.
5. Plug the firmware/operating system upgrade pack into the memory module socket.
6. Move the operating system write-protect jumper (J4) to the unprotected, or program, position.

Jumper J4, located in the bottom right corner of the motherboard, provides write protection from any download of a new operating system. The “out of the box” position of this jumper is “PROTECT,” or write protect. Without the jumper, the processors are write protected.

12. Move the operating system write-protect jumper (J4) back to the protected position (see diagram on page 3).
