Harsco Track Technologies

SERVICE BULLETIN MAINTENANCE OF WAY EQUIPMENT

DATE: 5-20-2003 **BULLETIN NO:** 03-008

TITLE: SLC 503 CPU OPERATING SYSTEM UPGRADE KIT #200713

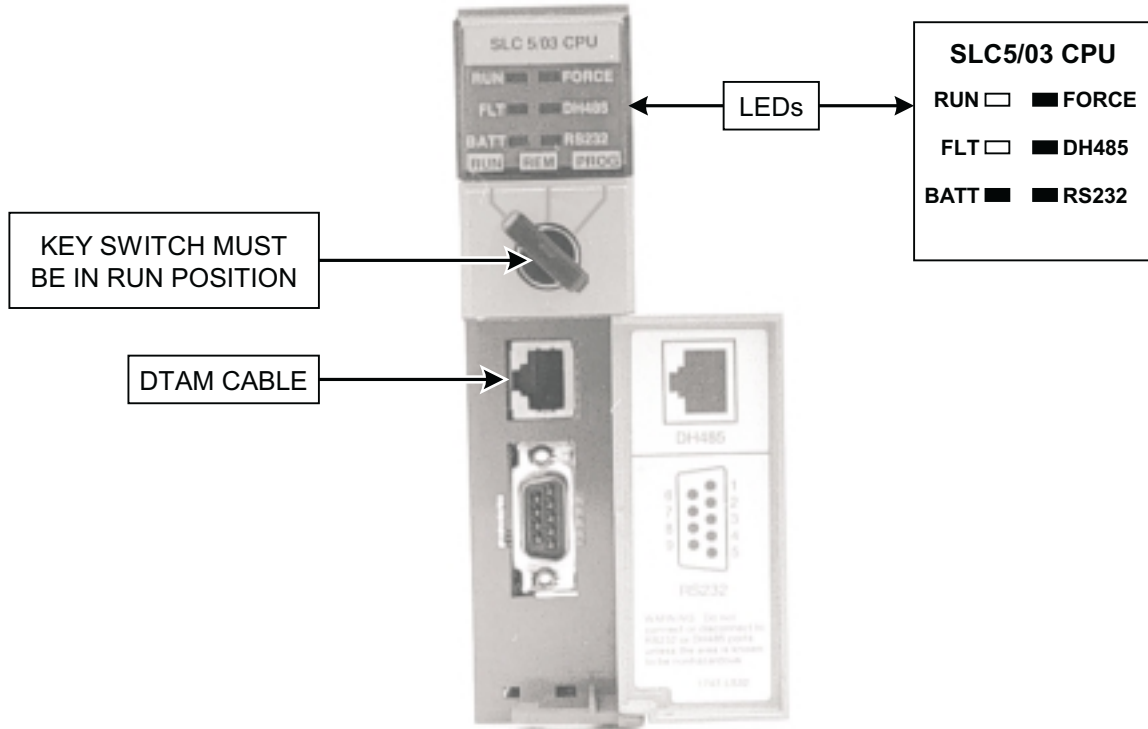
FIGURE 1
SLC 503 CPU MODULE - FRONT VIEW

12. After Operating System has been successfully upgraded in approximately 2-1/2 minutes, four LEDs (RS232 - DH485 - FORCE - BATT) on front of CPU Module will remain On steady as shown in Figure 1.

5. Remove existing M11 Memory Module #F026079 from socket on CPU Module.
6. **Important:** Move jumper from "PROTECT" to "PROGRAM" on CPU Module.
7. Remove Upgrade Module #FOR007526 from shipping package. Install Upgrade Module in socket on CPU Module.

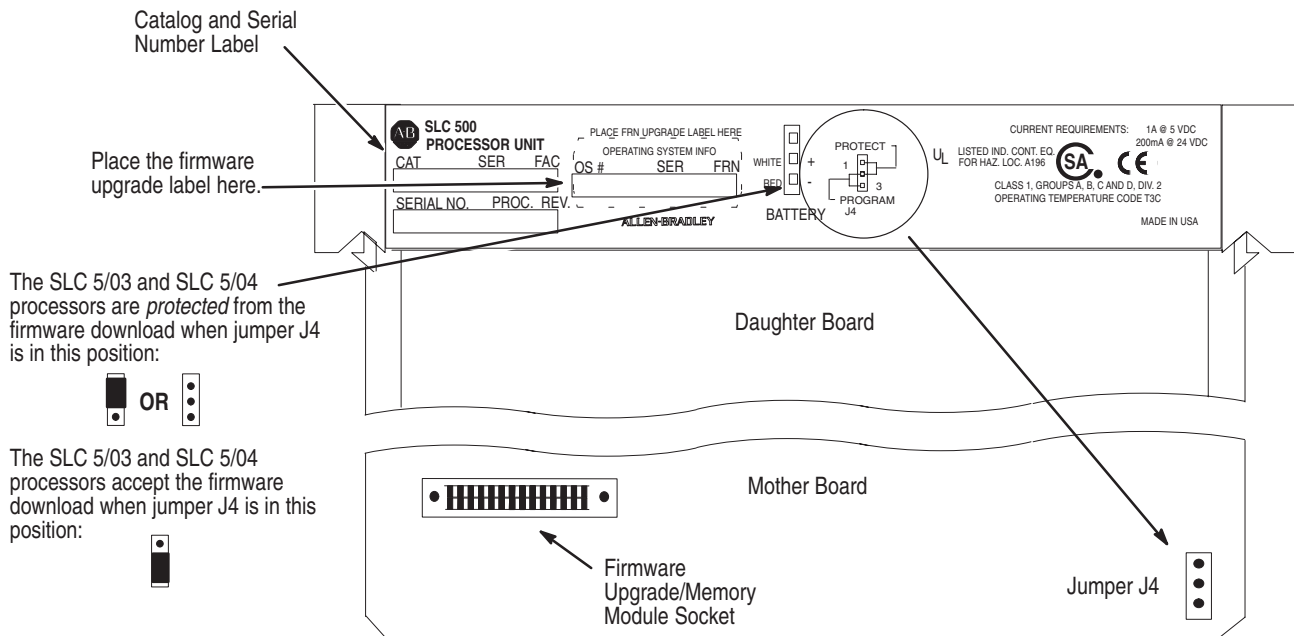
Figure 1 Component Placement Information

Jumper J4, located in the bottom right corner of the motherboard, provides write protection from any download of a new operating system. The “out of the box” position of this jumper is “PROTECT,” or write protect. Without the jumper, the processors are write protected.

4. Remove the processor from the chassis.
5. Plug the firmware/operating system upgrade pack into the memory module socket.
6. Move the operating system write-protect jumper (J4) to the unprotected, or program, position.
