Harsco

SERVICE BUILLETIN

MAINTENANCE OF WAY EQUIPMENT							
DATE:	2-2007			BULLETIN NO:	02-036A		
TITLE:	200457 STEERING STOP GROUP						
RATING:		DIRECTIVE (Action Is Required)	X	ALERT (Potential Problem)			
		INFORMATION (Action Is Optional)		PRODUCT IMPROVEM (Enhance Product)	IENT		
PRODUCT SE	Equipped	ODEL: All 2001 to presed With Series 0307, HR030 ® Guide Wheel Equipment	7A, HR	vrolet 2500HD 4X2 and 4 0307B, HR1000A or HR1			
SERIAL NO:	N/A						
SUMMARY:	Reports have been received that front wheels on 2001 to present Chevrolet 2500HD vehicles were found to have rubbed on the upper control arms when turning hard left or right, and particularly when bouncing on uneven ground. As a result, the anti-lock brake sensor wires have been cut. Therefore, we recommend to inspect the vehicle's front tires, wheels, upper control arms and anti-lock brake sensor wires for damage, wear, nicks, gouges, rubbing, cut or frayed wires, etc.

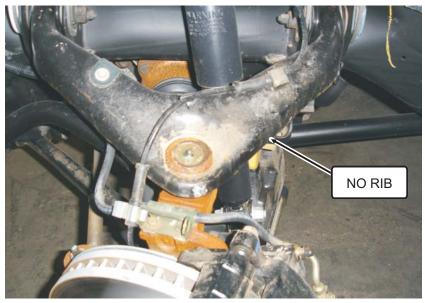
- 1. Determine if a control arm guard plate is or is not needed.
 - a. If the control arm on the vehicle does not have a rib, as shown in Figure 2, a guard plate is needed. Go to 3.1 Installing Control Arm Guard Plate.
 - b. If the control arm on the vehicle has a rib, as shown in Figure 3, a guard plate is not required. Go to 4.0 Anti-Lock Brake Sensor Wire Relocation.

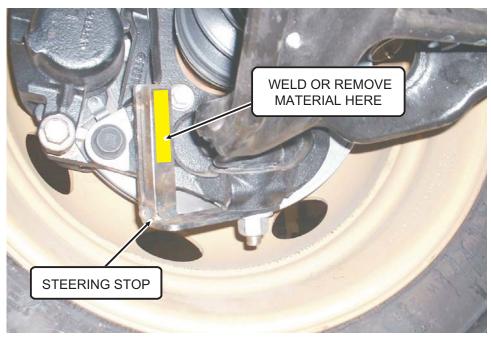
6.0 Steering Stop Modification - See Figure 7

- 4. If there is 3/8 1/2 inch (9.5 12.7 mm) of clearance, the clearance is acceptable.
- 5. If there is less than 3/8 1/2 inch (9.5 12.7 mm) of clearance or any contact at all, the steering stops must be modified. Go to 6.0 Steering Stop Modification.

- 3. Thoroughly clean the contact area of the steering stop surface of all dirt, grease, rust, etc. where material (not supplied) will be welded to.
- 4. If there was less than 3/8 1/2 inch (9.5 12.7 mm) of clearance or any contact at all, weld a 1 inch wide piece of suitable material to the steering stop surface in the area shown for the thickness needed and length required. Repeat the Wheel and Tire Clearance Inspection procedure. See 5.0 Wheel and Tire Clearance Inspection.

- 5. If there was more than 1/2 inch (12.2 mm) of clearance, use a grinder to remove material from the steering stop surface in the area shown. Do not remove more than 1/16 inch (1.6 mm) material before rechecking the vehicle wheel clearance. Repeat the Wheel and Tire Clearance Inspection procedure. See 5.0 Wheel and Tire Clearance Inspection.
