Harsco Track Technologies

SERVICE BULLETIN MAINTENANCE OF WAY EQUIPMENT

BULLETIN NO: 08-001

TITLE: Hydraulic Pump Motor Rework

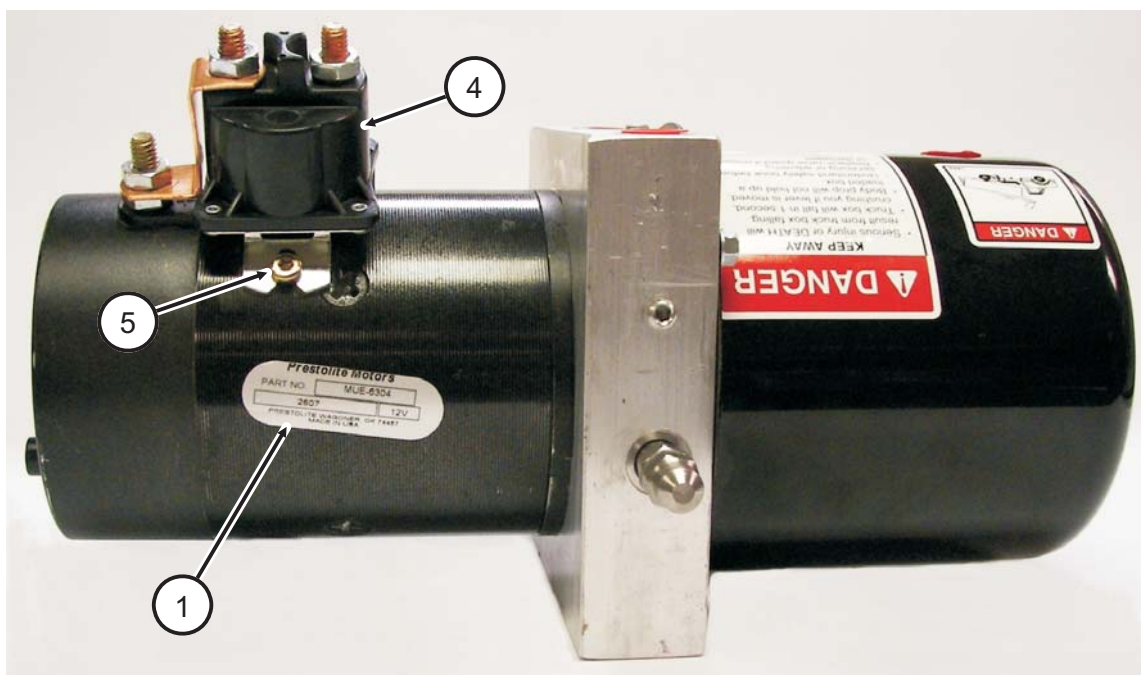
FIGURE 1
HYDRAULIC POWER UNIT IDENTIFICATION

1. See Figure 1. First, determine if the hydraulic power unit you have is the type that requires re-work. The appearance of the unit will be the same as shown in Figure 1. If present, the manufactures name tag (1) will indicate that it is a Prestolite motor and the model number will be MUE 6304.

- See Figure 1. If solenoid (4) is removed and relocated to a different position, such as under the hood of the vehicle, the solenoid mounting screws (5) must be replaced in the motor housing. The screws should be installed using Loc-Tite. If screws (5) are not replaced, the screw holes need to be filled with a silicone type sealant.
