SERVICE BULLETIN

BULLETIN NO: 09-008

TITLE: Axle Inspection

PRODUCT SERIES / MODEL: HR1500 Series B2 and B3 HY-RAIL® Guide Wheel Units.

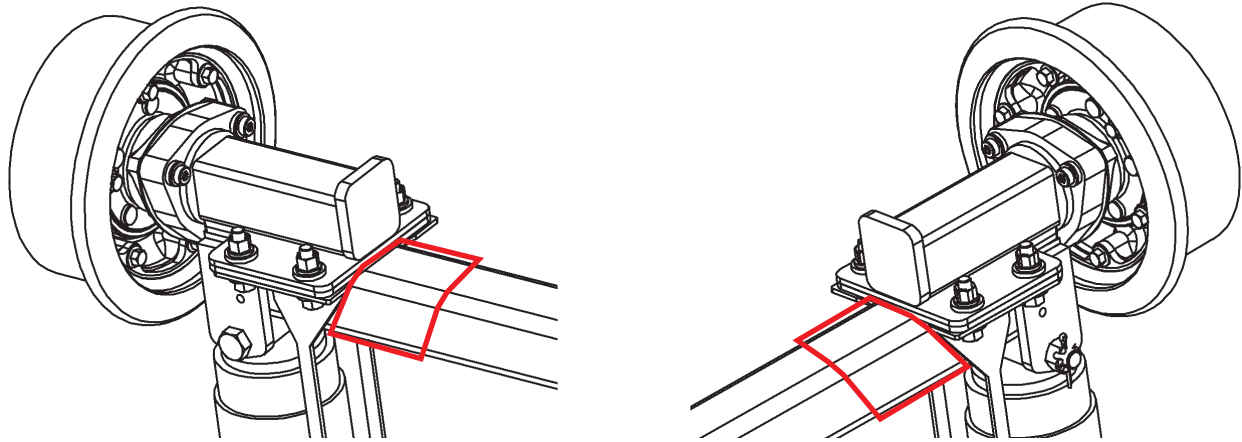
**FIGURE 1
AXLE INSPECTION**

ACTION: Clean and visually inspect the both ends of the axle near the stub axle mounting plates. The cracks may first develop on the bottom and the front or rear sides of the axle. If any crack in the axle is found, the vehicle must be removed from service immediately and taken to an approved HY-RAIL® guide wheel unit repair facility. The facility must replace the axle before the vehicle can be returned to service.

1. Clean the areas outlined in red as shown in Figure 1. If the area has a heavy buildup of dirt, grease or oil, power wash the area first. Use a wire brush to clean the area and then wipe the area clean with a shop rag. Visually inspect the area outlined in red. The cracks may be very small so it is important to carefully inspect the area.

2. If any cracks are found, The vehicle must be removed from service immediately and taken to an approved HY-RAIL® guide wheel unit repair facility. The facility must replace the axle. After the axle is replaced, the guide wheel unit load must be checked and if necessary, adjusted. The Guide Wheel Equipment Alignment Procedure must also be performed. Once completed, the vehicle can be returned to service.
