## SERVICE BULLETIN

**BULLETIN NO:** 14-007

**TITLE:** Integral Spindle Mounting Bolts

**PRODUCT SERIES / MODEL:** HR1500 Series B2, HR1500 Series B3 and HR1500 Series C1  
HY-RAIL® Guide Wheel Units

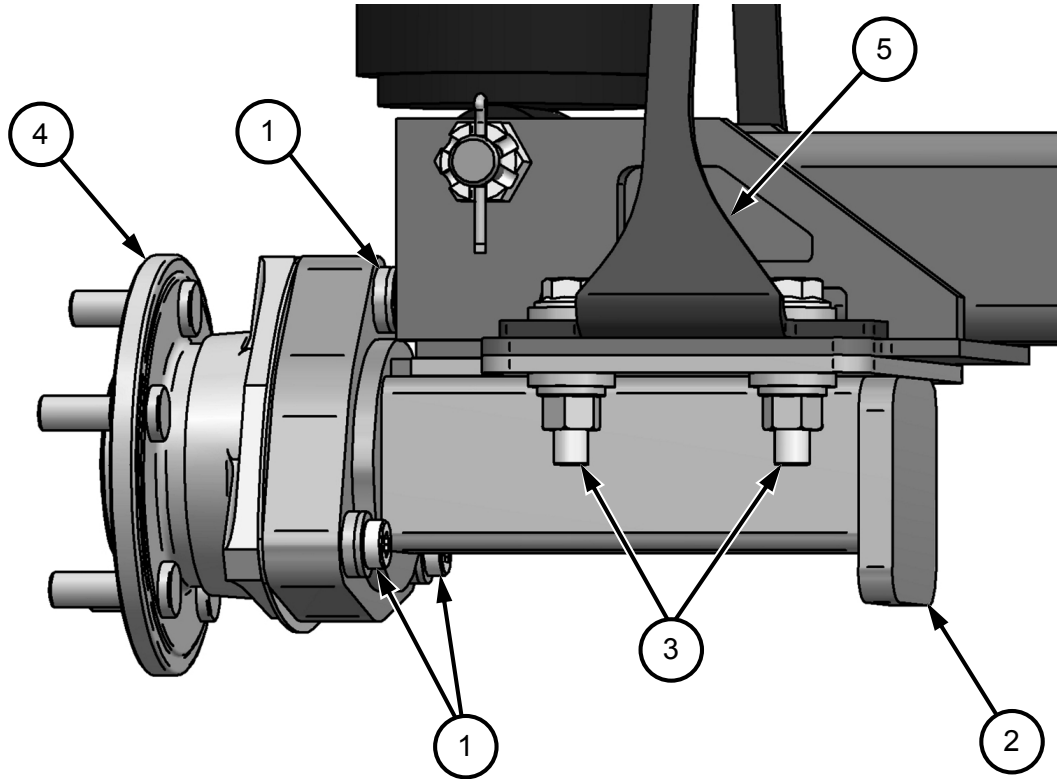
FIGURE 1  
INTEGRAL SPINDLE AND STUB AXLE ASSEMBLY

**OPERATIONAL IMPACT:** Integral spindle mounting bolts could become loose and / or break if improper repair procedures are used when the integral spindle is replaced on the guide wheel unit. Failure of the integral spindle mounting bolts may result in the loss of the guide wheel.

2. To be able to remove and re-install the three M12 socket head cap screws (1) properly, the stub axle (2) will need to be removed from the guide wheel unit.

3. Remove the four 1/2"-20 disc lock nuts, washers and hex head cap screws (3) to remove the stub axle (2). Place the stub axle in a vice to hold it securely.

4. Remove the three M12 socket head cap screws, washers and insulating washers (1) being careful not to damage the insulating bushings inside the mounting holes. Remove integral spindle (4) from stub axle (2).

7. Apply Blue Loctite 242 to the threads on the three M12 socket head cap screws (1). Install the integral spindle on the stub axle.
8. Secure the integral spindle to the stub axle with the three M12 socket head cap screws. Make sure the M12 hardened washers and insulating washer are properly in place between the M12 socket head cap screws and the flange on the stub axle. Torque the M12 socket head cap screws (1) to 60 lb-ft (81 N-m).

9. Assemble the stub axle and axle strap (5) (if present) to the guide wheel unit using the four 1/2"-20 disc lock nuts, washers and hex head cap screws (3). Position the stub axle as close as possible to its original position when it was removed.

10. Torque the four 1/2"-20 disc lock nuts to 110 lb-ft (149 N-m).
11. Re-align the guide wheel equipment on the vehicle before returning the vehicle to service.
