Harsco Track Technologies

SERVICE BULLETIN MAINTENANCE OF WAY EQUIPMENT

DATE: 9-8-2004 **BULLETIN NO:** 04-008

TITLE: REINFORCEMENT GROUP #203160

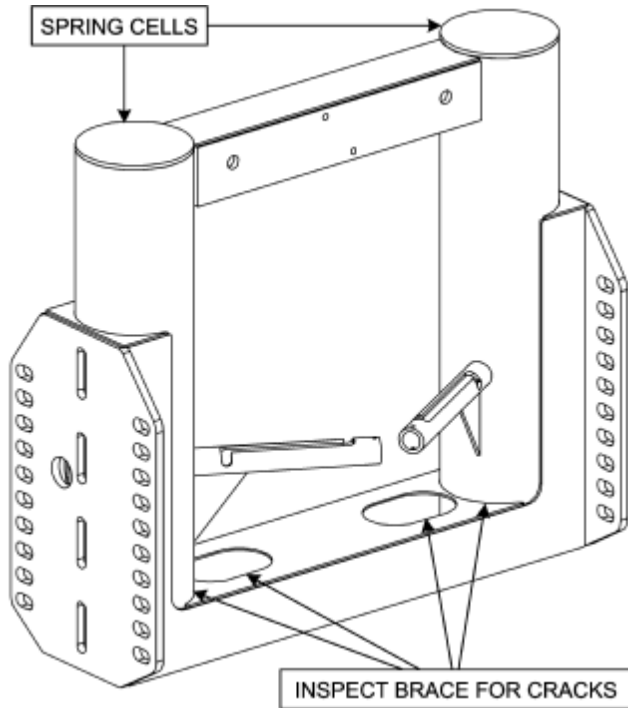
FIGURE 1

SUMMARY: Under certain operating conditions, stress cracks have been found to develop in the lower support brace located in-between the spring cells of the front rail pilot unit frame. Inspect the lower support brace for cracks. If any cracks are found and it is desired to reinforce the support brace, a Reinforcement Group #203160 is available.

OPERATIONAL IMPACT: The stress cracks in the lower support brace are not a structural defect and will not affect the operation of the front rail pilot unit.

1. Inspect the lower support brace located in-between the spring cells of front rail pilot unit frame for cracks as shown in Figure 1.
2. If any cracks are found and it is desired to reinforce the support brace, order one Reinforcement Group #203160 per vehicle and install per the Instructions in this Service Bulletin.

LOWER SUPPORT BRACE INSPECTION

ACTION: Inspect the lower support brace in-between the spring cells of the front rail pilot unit for cracks. If any cracks are found and it is desired to reinforce the support brace, order one Reinforcement Group #203160 per vehicle.

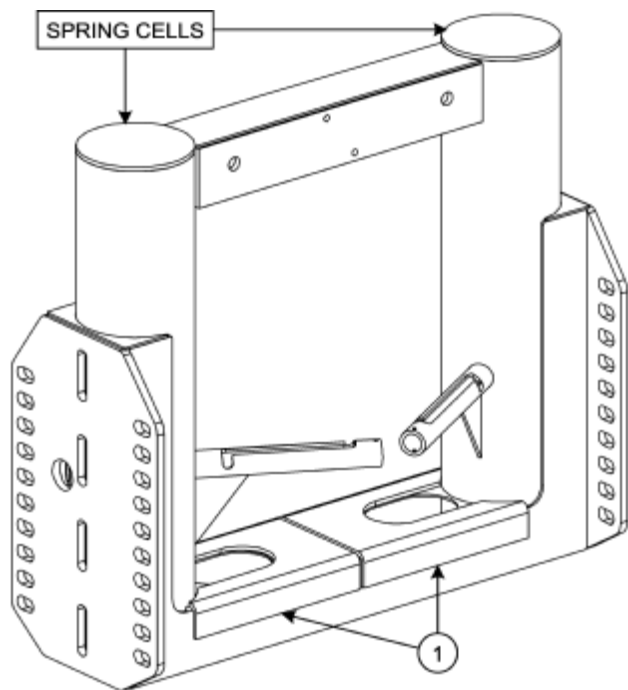
FIGURE 2

REINFORCEMENT INSTALLATION

3. **Important:** Before welding on the vehicle, disconnect all electrical cables from the battery and from the alternator. Also refer to the vehicle Operator's Manual for any additional precautions that must be taken before welding on the vehicle.
4. Thoroughly clean the existing support brace and spring cells of the front rail pilot unit frame of all dirt, grease, rust, etc. where the two support plates (1) will be welded to.
5. Lay the two support plates (1) on top of the lower support brace in-between the spring cells as shown in Figure 2 and weld in place per the weld symbols shown in Figure 3.

Note: Some applications may require grinding of the support plates (1) for a proper fit.

LAY SUPPORT PLATES (1) ON TOP OF LOWER SUPPORT BRACE IN-BETWEEN SPRING CELLS AND WELD IN PLACE.
NOTE: SOME APPLICATIONS MAY REQUIRE GRINDING OF THE SUPPORT PLATES (1) FOR PROPER FIT.

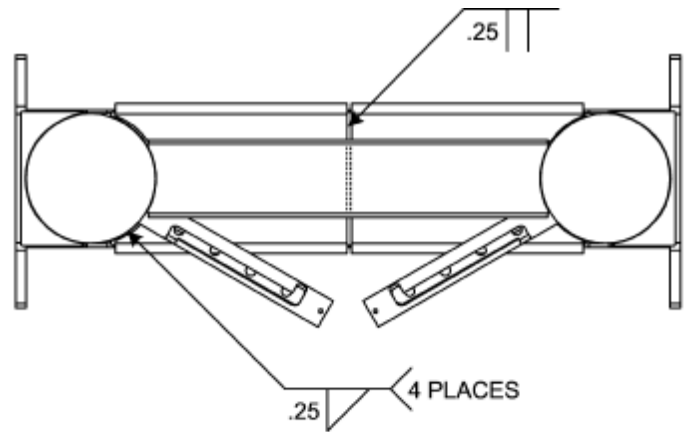
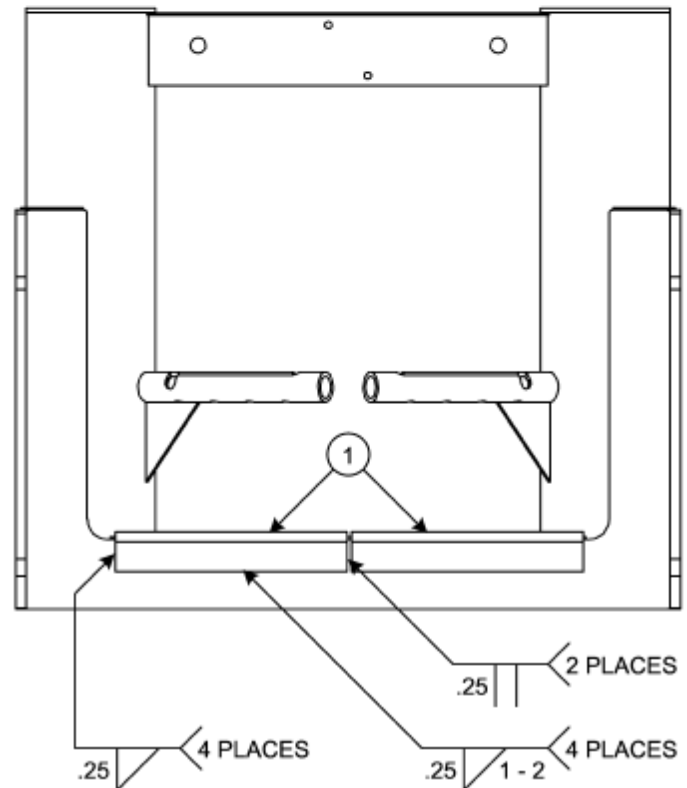
FIGURE 3

REINFORCEMENT WELDING

6. After welding, wire brush and clean all welds. Then paint all welds to prevent rust.
7. Reconnect all electrical cables that were disconnected.
