# Harsco Track Technologies

## SERVICE BULLETIN MAINTENANCE OF WAY EQUIPMENT

**DATE:** 2-6-2007 **BULLETIN NO:** 07-003

**TITLE:** CHARGE PUMP CIRCUIT CHANGE

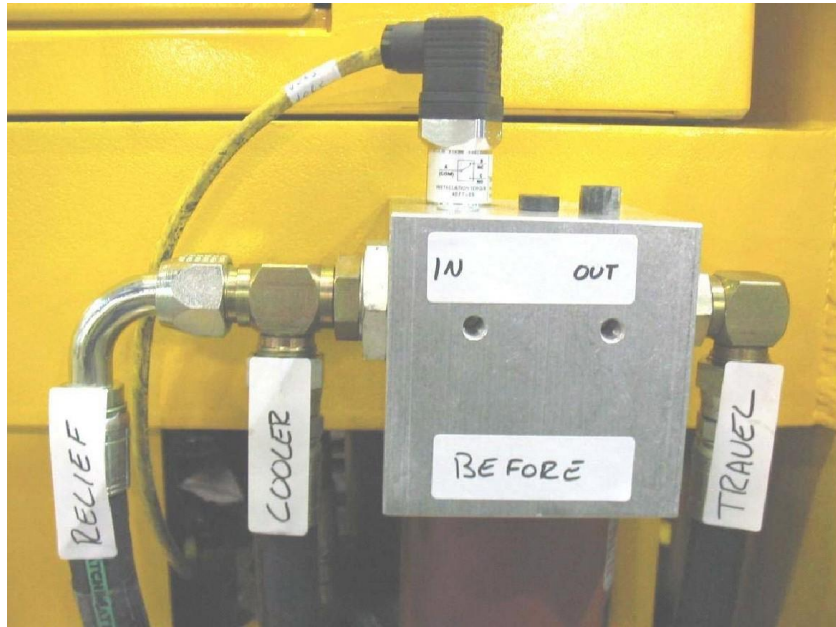
FIGURE 1  
INCORRECT PIPING

3. If the Charge Pump Circuit Filter piping is the same that is shown in Figures 1 and 3, the piping is **INCORRECT** and it must be changed. Go to Step 5 - Changing Piping.

- In Port: A Tee Fitting was installed in the "IN" Port of the Filter Head and the hoses from the Cooler Fan Motor and from the Relief Valve were connected to the Tee Fitting.
- Out Port: A 90° Fitting was installed in the "OUT" Port of the Filter Head and the hose to the Travel Pump was connected to the 90° Fitting.

5. If the current Charge Pump Circuit Filter piping is incorrect, disconnect the hoses from the fittings in the Filter Head ports. Then remove the fittings from the Filter Head.
6. Remove the Filter from its mounting location on the machine, turn 180° so the ports are facing the opposite directions, and then re-install the Filter in its original mounting location.
7. Install the fittings in the Filter Head ports and reconnect the hoses as follows:
  - In Port: A 90° Fitting is installed in the "IN" Port of the Filter Head and the hose from the Cooler Fan Motor is connected to the 90° Fitting.
  - Out Port: A Tee Fitting is installed in the "OUT" Port of the Filter Head and the hoses to the Travel Pump and to the Relief Valve are connected to the Tee Fitting.

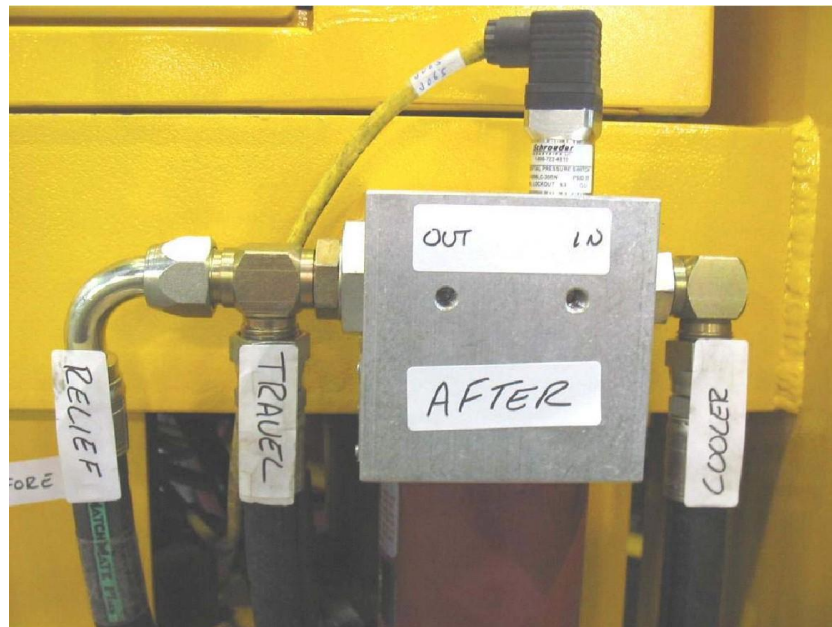
FIGURE 2  
CORRECT PIPING

4. If the Charge Pump Circuit Filter piping is same that is shown in Figures 2 and 4, the piping is correct and it does not have to be changed. Go to Step 8 - Filter Elements.

- In Port: A 90° Fitting is installed in the "IN" Port of the Filter Head and the hose from the Cooler Fan Motor is connected to the 90° Fitting.
- Out Port: A Tee Fitting is installed in the "OUT" Port of the Filter Head and the hoses to the Travel Pump and to the Relief Valve are connected to the Tee Fitting.
