# SERVICE BULLETIN

# MAINTENANCE OF WAY EQUIPMENT

<b>40.</b>
<b>DATE</b> : 12-2016				<b>BULLETIN NO</b> : 16-006A
TITLE:	Integral Spindle Inspection			
RATING:		<b>DIRECTIVE</b> (Action Is Required)		ALERT (Potential Problem)
	X	INFORMATION (Action Is Optional)		PRODUCT IMPROVEMENT (Enhance Product)
PRODUCT SI	ERIES / M	ODEL: HR1500 Series Guide Wheel Ur		R1500 Series C HY-RAIL®
SERIAL NO:	N/A			
SUMMARY:	Harsco Rail HR1500 Series B and HR1500 Series C Guide Wheel Units are equipped with maintenance free integral spindle bearing hubs. All bearings, including maintenance free types, wear with usage and will eventually need to be replaced. If the guide wheel equipment is used with a failed integral spindle bearing hub additional damage, including derailment, could occur.  Harsco Rail is making users aware, via this Service Bulletin, of the inspection interval and procedures for maintenance free integral spindle bearing hubs on the HR1500 Series B and HR1500 Series C guide wheel units.

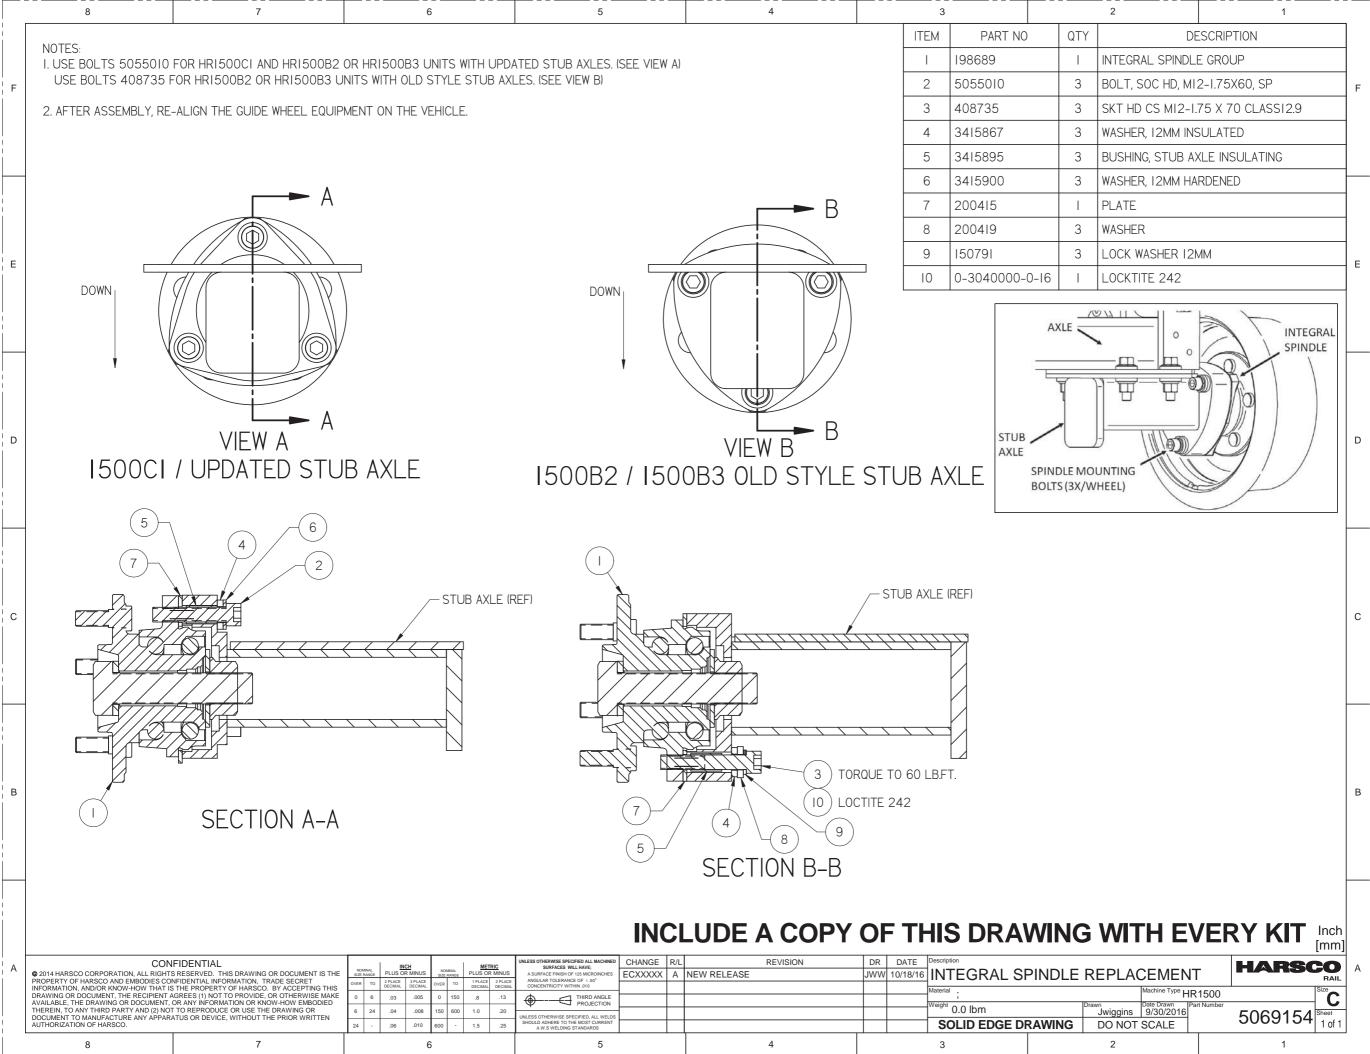
FIGURE 3
HUB ROTATED AND PULLED OUT, INDICATOR READS .020"
THIS EXCEEDS 0.005" SPECIFICATION, INTEGRAL SPINDLE SHOULD BE REPLACED

- 9. Next, pull the outer edge of the integral spindle bearing hub flange while rotating the hub approximately 90° clockwise and counter-clockwise at least five times.

- Observe the total dial indicator movement during the rotation. If it exceeds 0.005", the integral spindle bearing hub should be replaced. Harsco Rail recommends using the Integral Spindle Replacement Kit, Harsco Rail # 5069154.
