SERVICE BULLETIN

BULLETIN NO: 15-002B

TITLE: HR1800 Series, HR1900 Series and HR2000 Series B HY-RAIL®
Brake Air Compressor Kits

PRODUCT SERIES / MODEL: HR1800 Series, HR1900 Series and HR2000 Series B
HY-RAIL® Guide Wheel Equipment

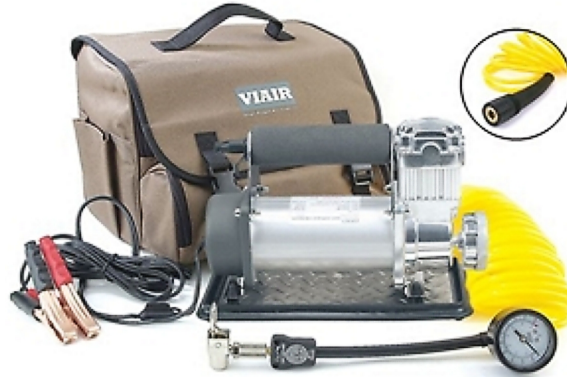
OPERATIONAL IMPACT: The incorrect air compressor could malfunction which will reduce braking effectiveness of the vehicle while on rail. This may result in longer braking distance required to stop the vehicle on rail.

FIGURE 1
INCORRECT AIR COMPRESSOR
VIAIR 400P, Model # 40043

4. If you have one of the correct air compressors as shown in Figure 2, no further action is required. If you have the incorrect air compressor like the one shown in Figure 1, it must be replaced with the correct one supplied by Harsco Rail.

6. Contact Harsco Rail and order Part Number 5046905 to obtain the correct air compressor. Remove the vehicle from service and take it to an approved HY-RAIL® guide wheel equipment repair facility to have the incorrect compressor replaced. After the air compressor has been replaced, the vehicle can be returned to service.

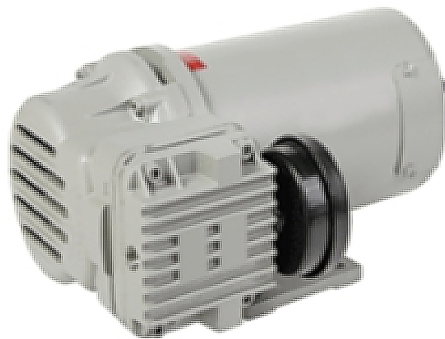
FIGURE 2
CORRECT AIR COMPRESSORS
Thomas Industries TA-3101-DC, Model # 270024
Harsco Rail # F025423
(Obsolete, Replace by # 5046905)

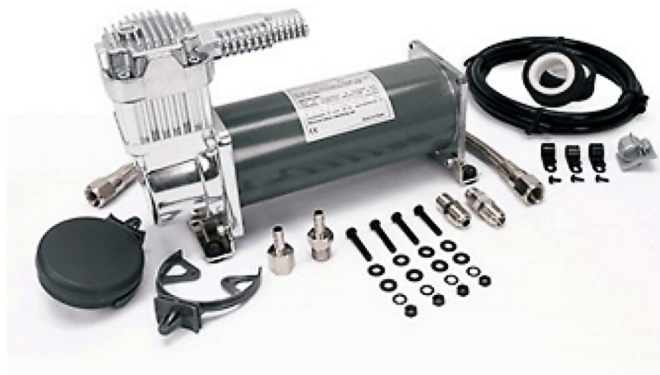
Viair 450C-IG, Model # 45050
Harsco Rail # 5046905
